# Metricon stadium training field

## CIRCULAR DRAINAGE SYSTEM

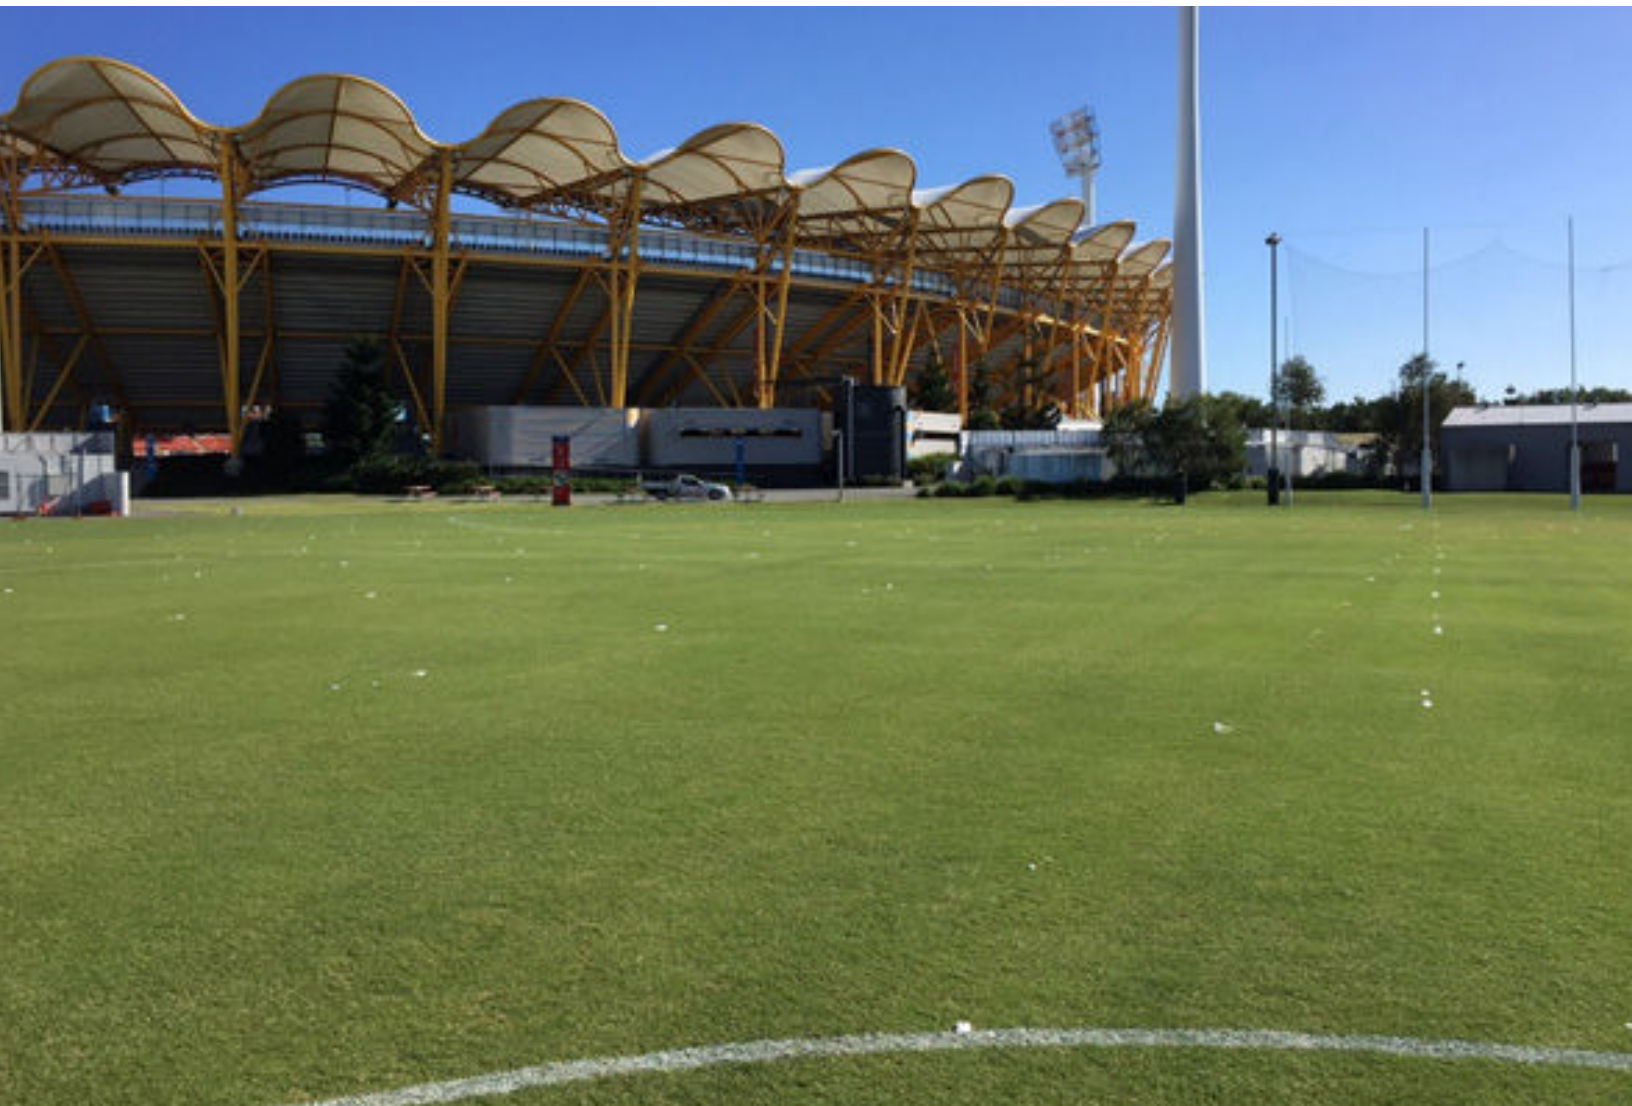
20,000 m<sup>2</sup>

*Hanceys turf were contacted and asked to install a drainage system capable of handling heavy rainfall (as much as 100mm per hour due to the severity of summer storms) as well as irrigation pipework and upgrading of the existing irrigation system.*

This system uses 100mm lateral agi pipes at 300mm depth below finished levels, at 5 meter centres to pick up any rainfall and take it into 4 x 150mm main drains falling diagonally from centre of field to an outer ring main drain which circled the field. We decided to tap this outer ring main into three separate outlets near the main stadium which in turn dispose of water into the stormwater then out to surrounding the roadways.

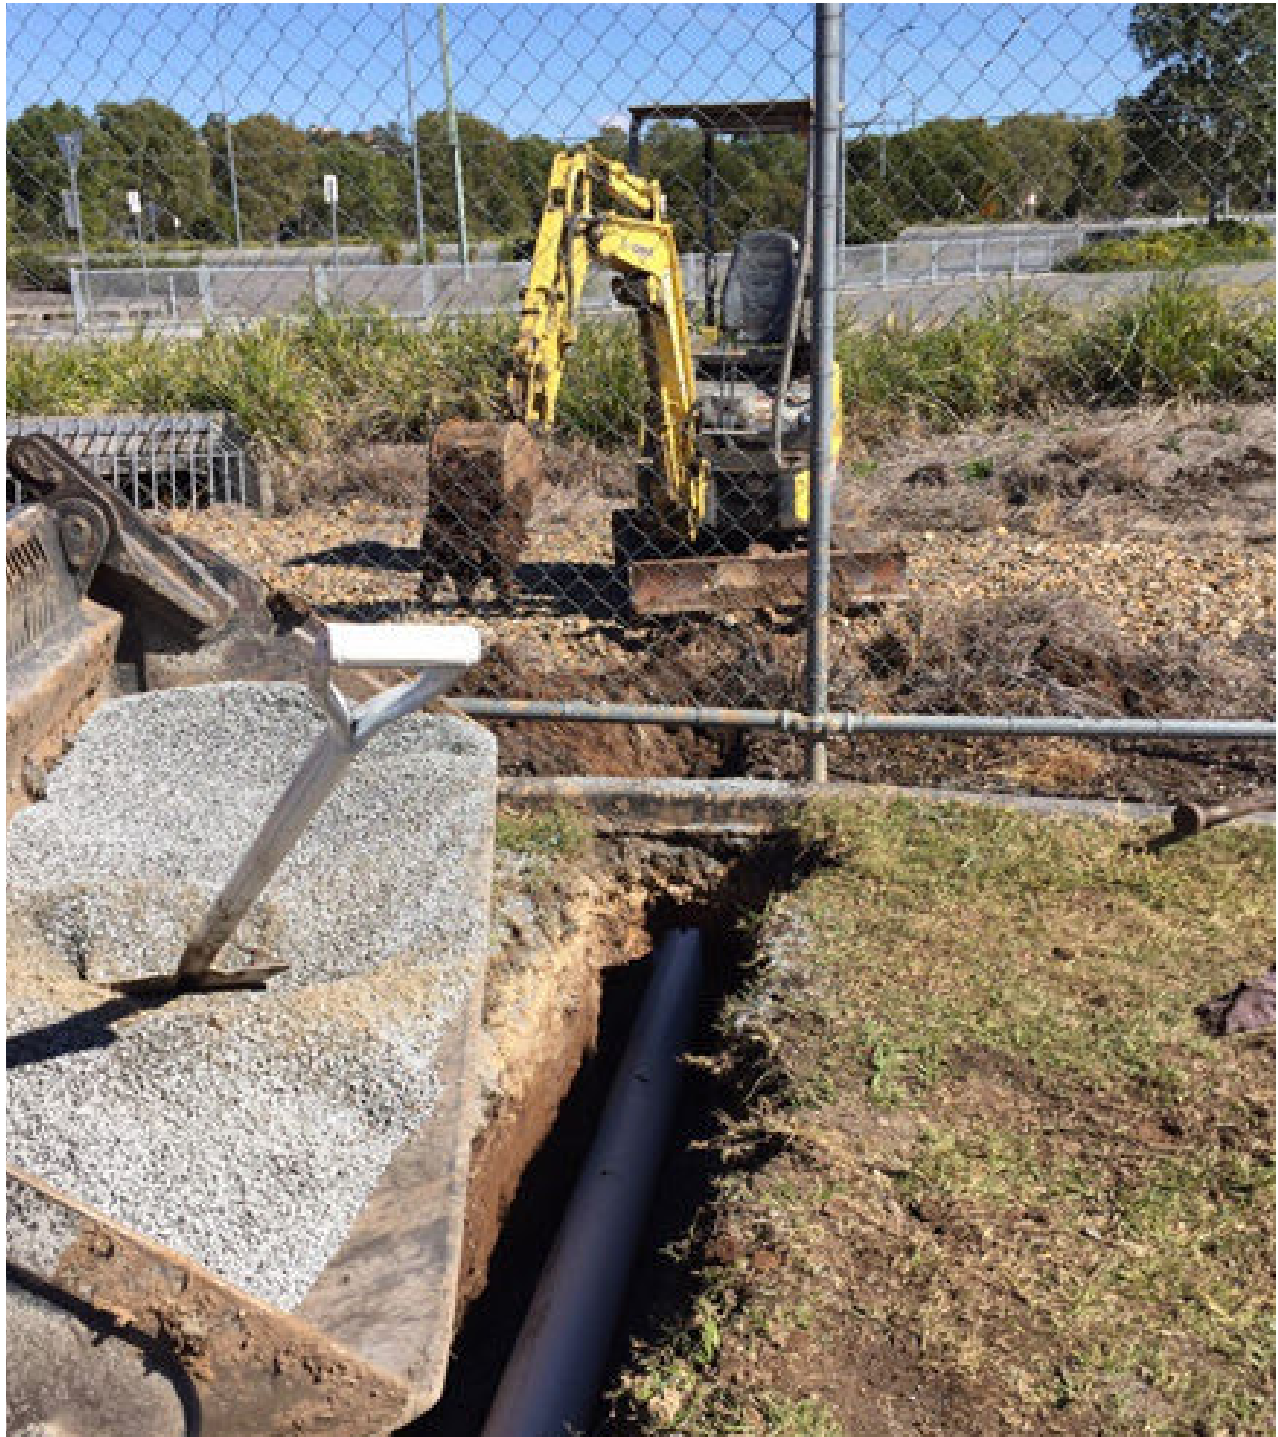
One of the main outlets being trenching in,  
200mm PVC stormwater pipe used for outlets

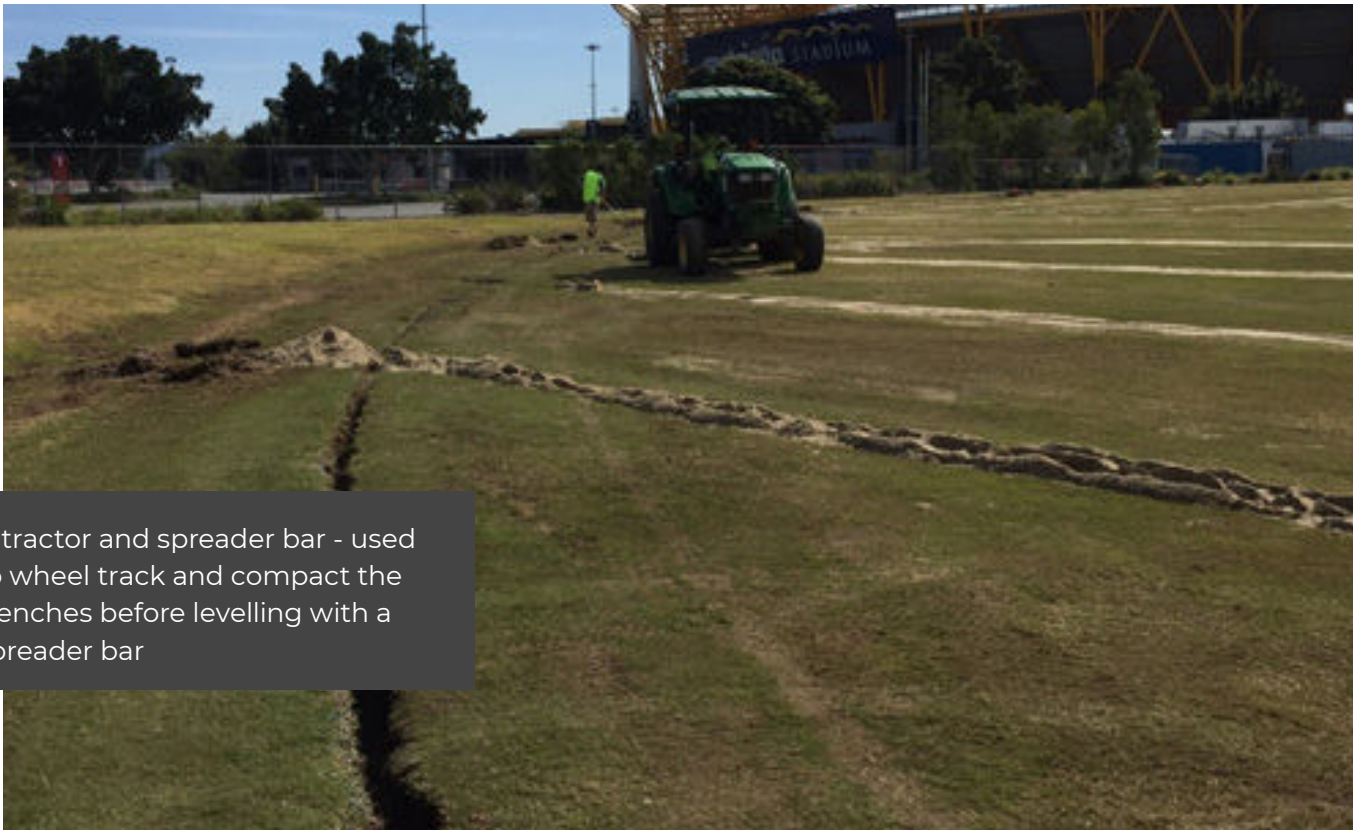
A tractor and spreader bar - used to wheel track and compact the trenches before levelling with a spreader bar

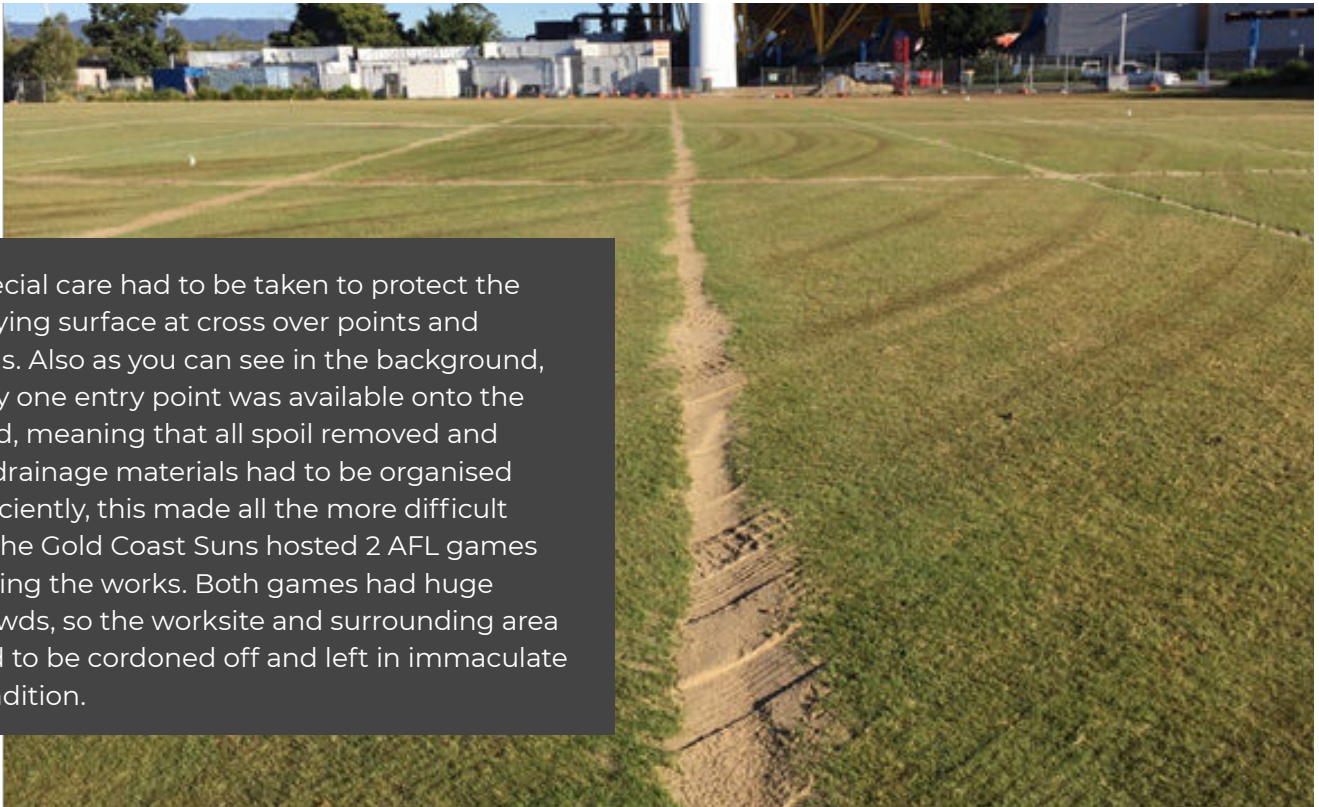
Special care had to be taken to protect the playing surface at cross over points and joins. Also as you can see in the background, only one entry point was available onto the field, meaning that all spoil removed and all drainage materials had to be organised efficiently, this made all the more difficult as the Gold Coast Suns hosted 2 AFL games during the works. Both games had huge crowds, so the worksite and surrounding area had to be cordoned off and left in immaculate condition.

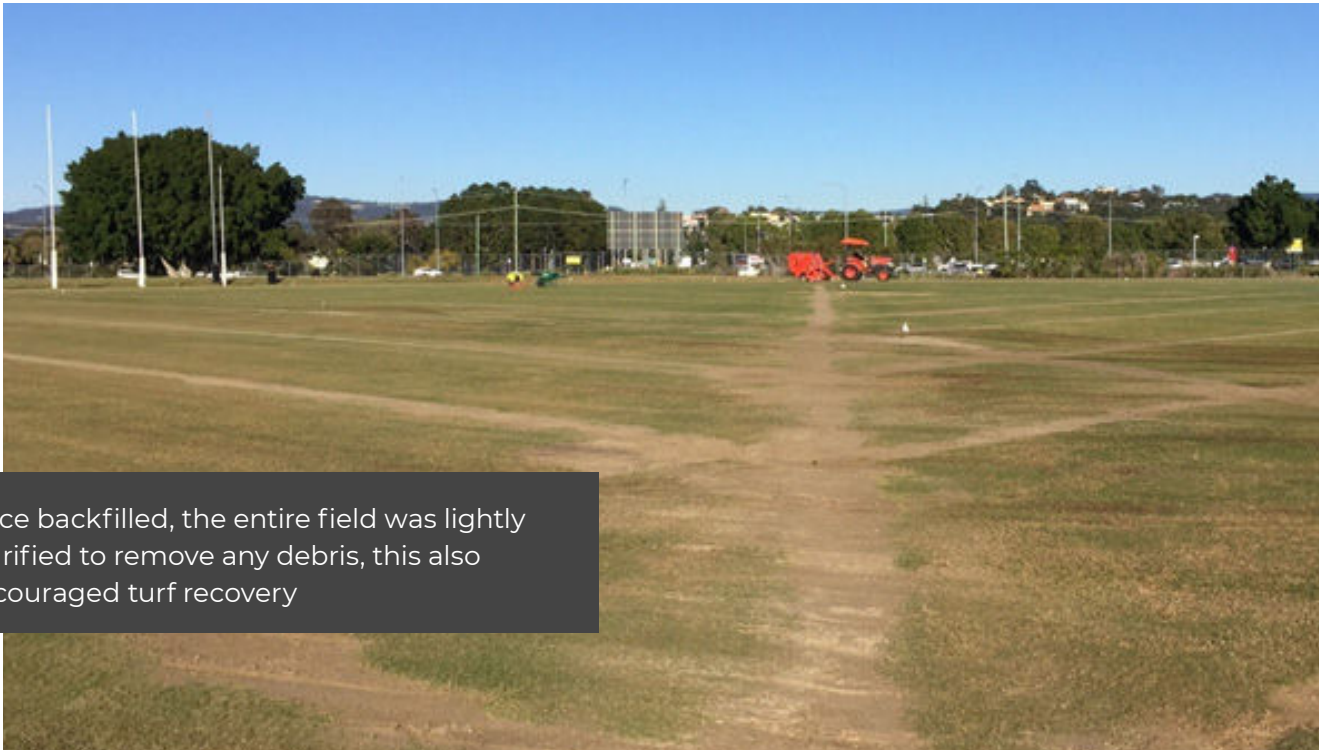
Once backfilled, the entire field was lightly scarified to remove any debris, this also encouraged turf recovery

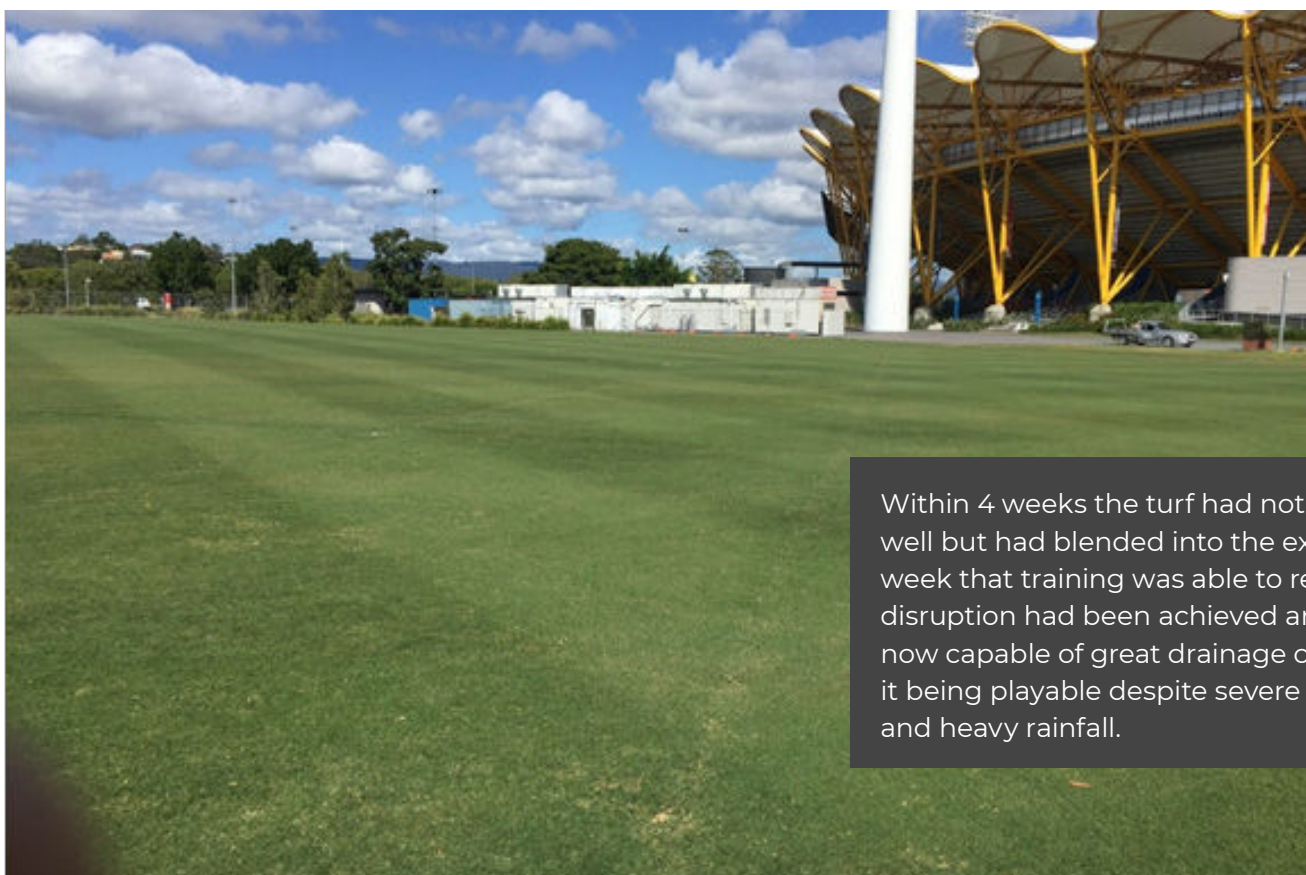
Trench lines were then turfed with Wintergreen couch, matching the existing cultivar on the field. Turf was harvested in 1.2m by 600mm slabs which were then cut to 200mm in width so as to cover the trench perfectly. The turf was also washed before arriving on site, so that the drain lines were not contaminated with any soil and remained pure sand achieving maximum drainage capacity.

Within 4 weeks the turf had not only taken well but had blended into the existing field so well that training was able to resume. Minimal disruption had been achieved and a field was now capable of great drainage characteristics, it being playable despite severe thunderstorms and heavy rainfall.
