Metricon stadium training field

CIRCULAR DRAINAGE SYSTEM

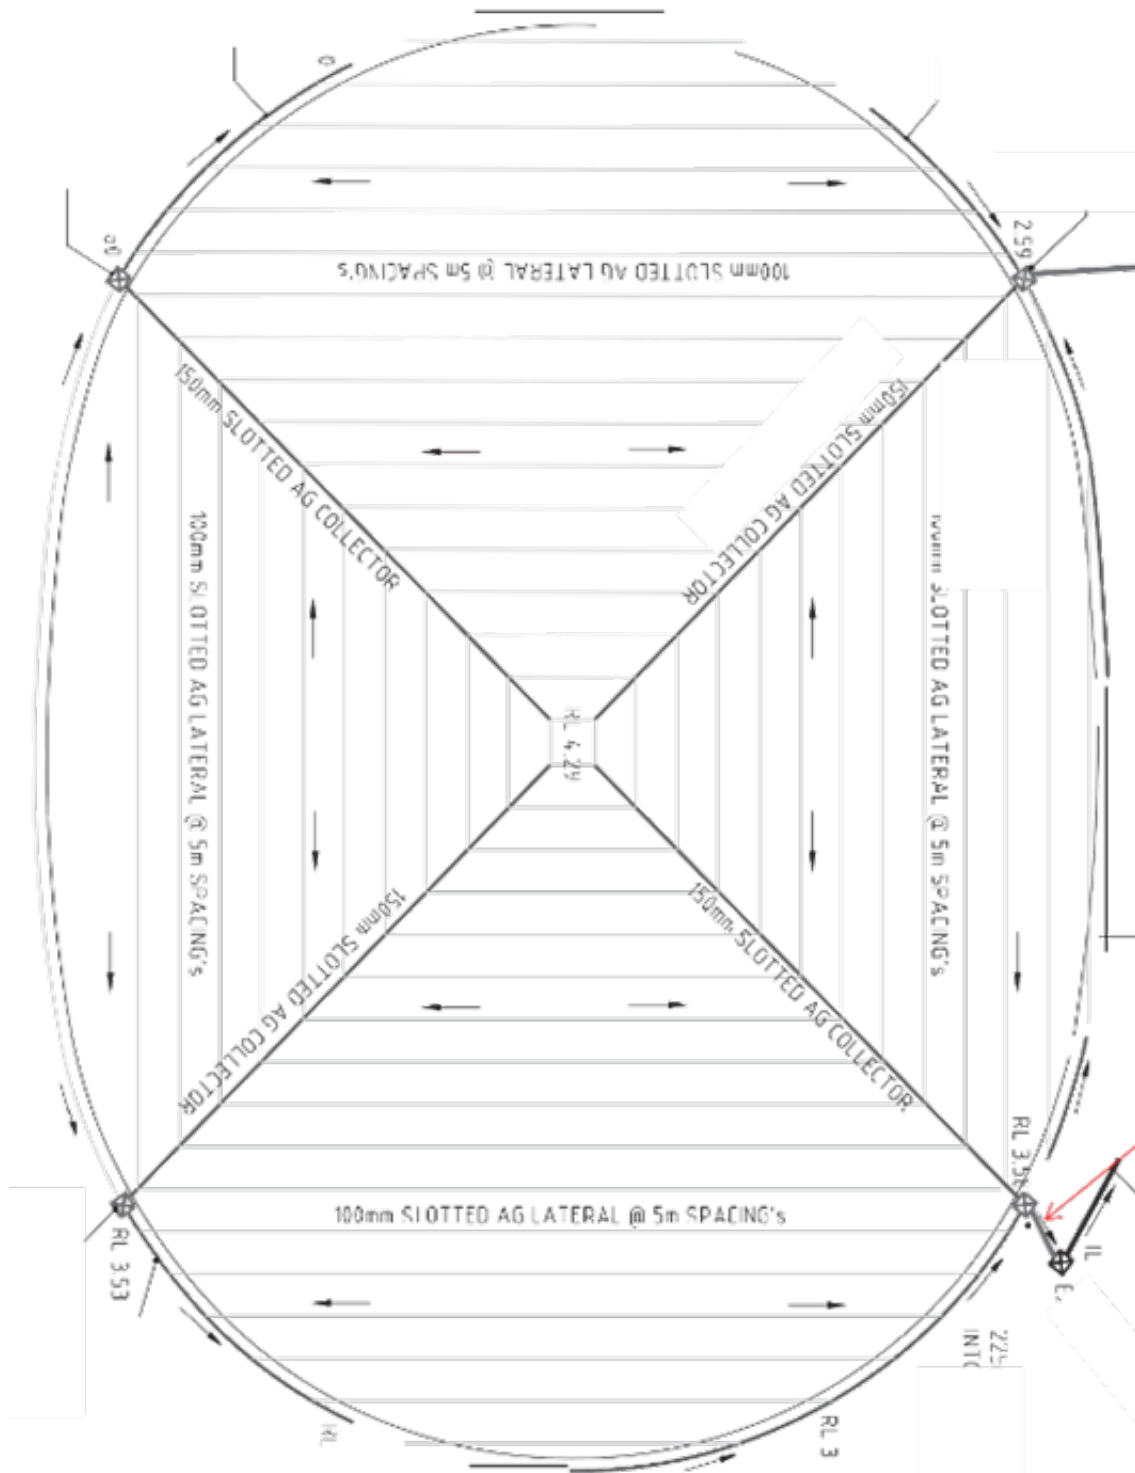
This system uses 100mm lateral agi pipes at 300mm depth below finished levels, at 5 meter centres to pick up any rainfall and take it into 4 x 150mm main drains falling diagonally from centre of field to an outer ring main drain which circled the field. We decided to tap this outer ring main into three separate outlets near the main stadium which in turn dispose of water into the stormwater then out to surrounding the roadways.

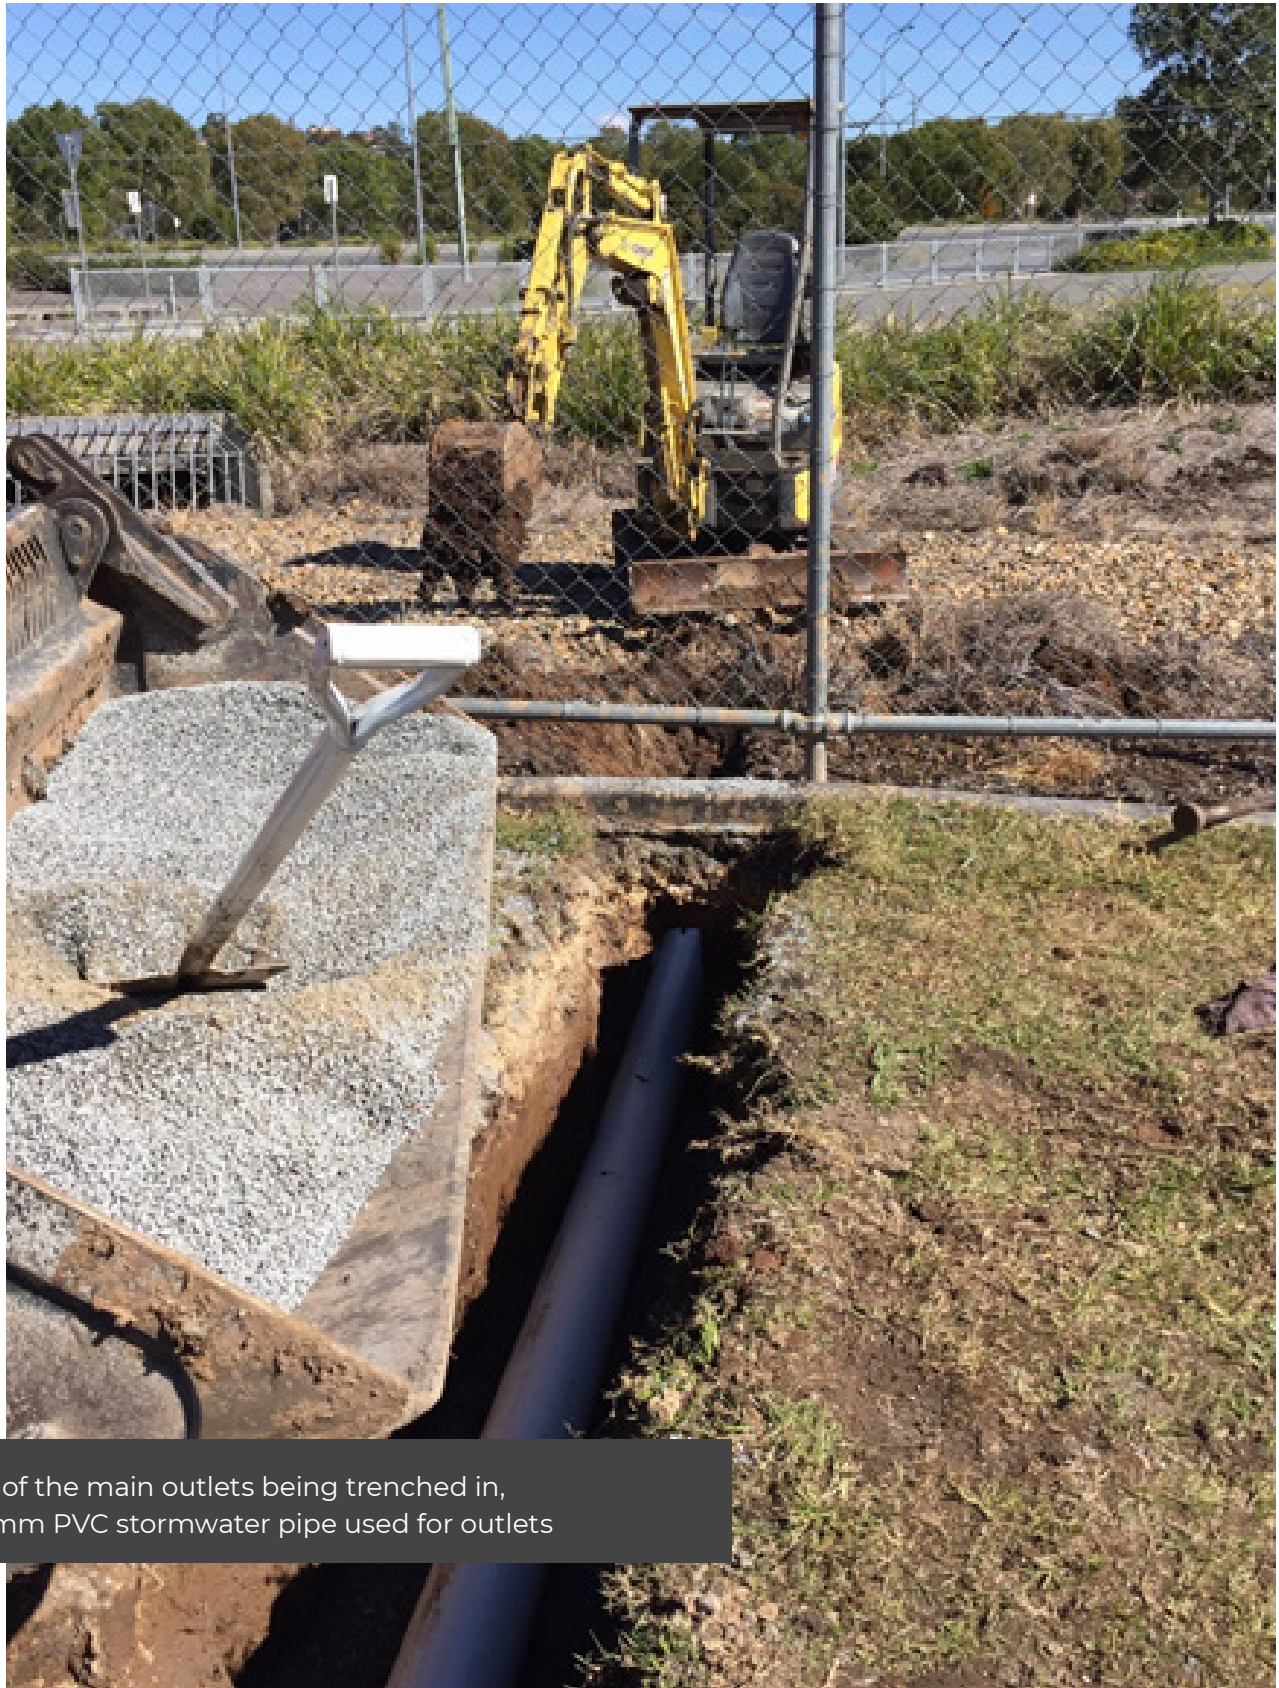
One of the main outlets being trenched in, 200mm PVC stormwater pipe used for outlets

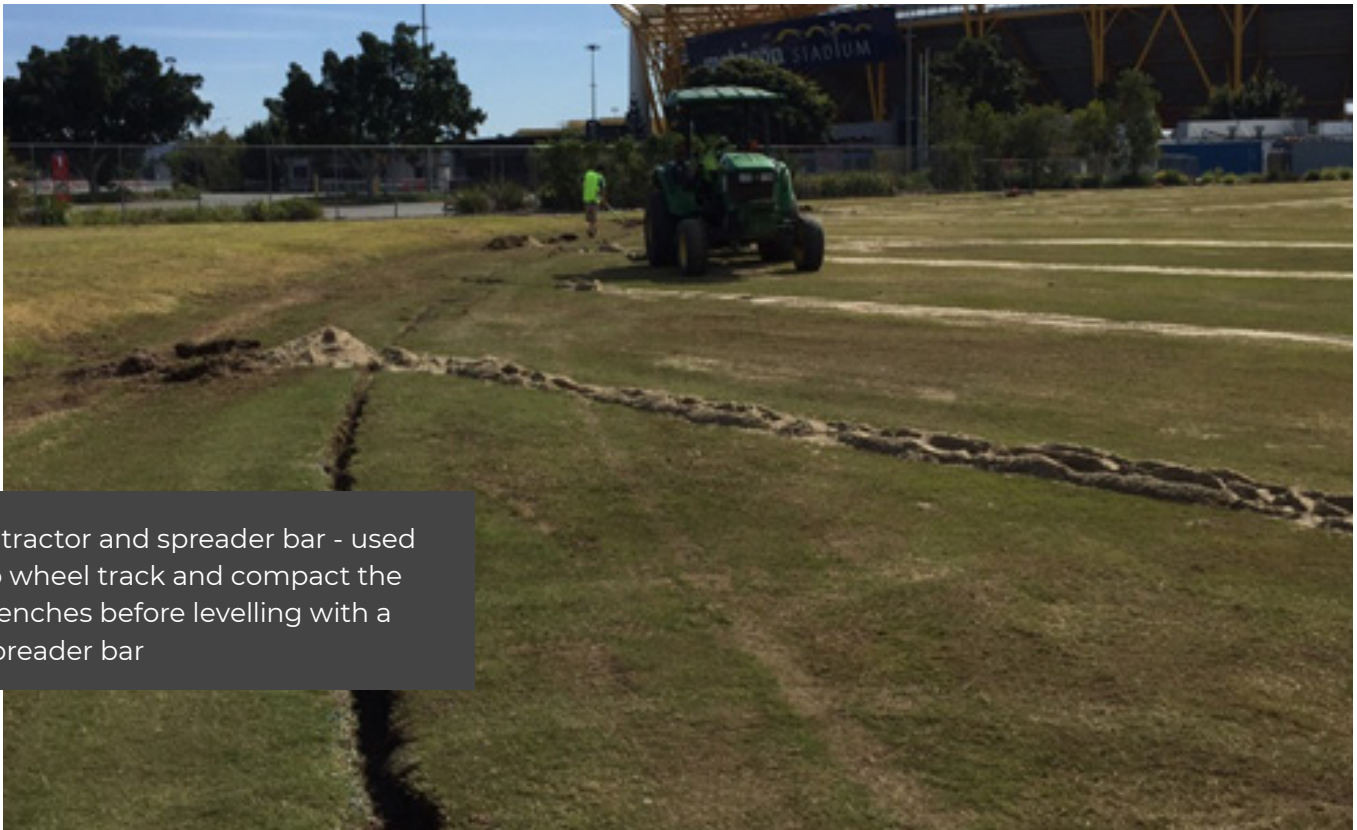
A tractor and spreader bar - used to wheel track and compact the trenches before levelling with a spreader bar

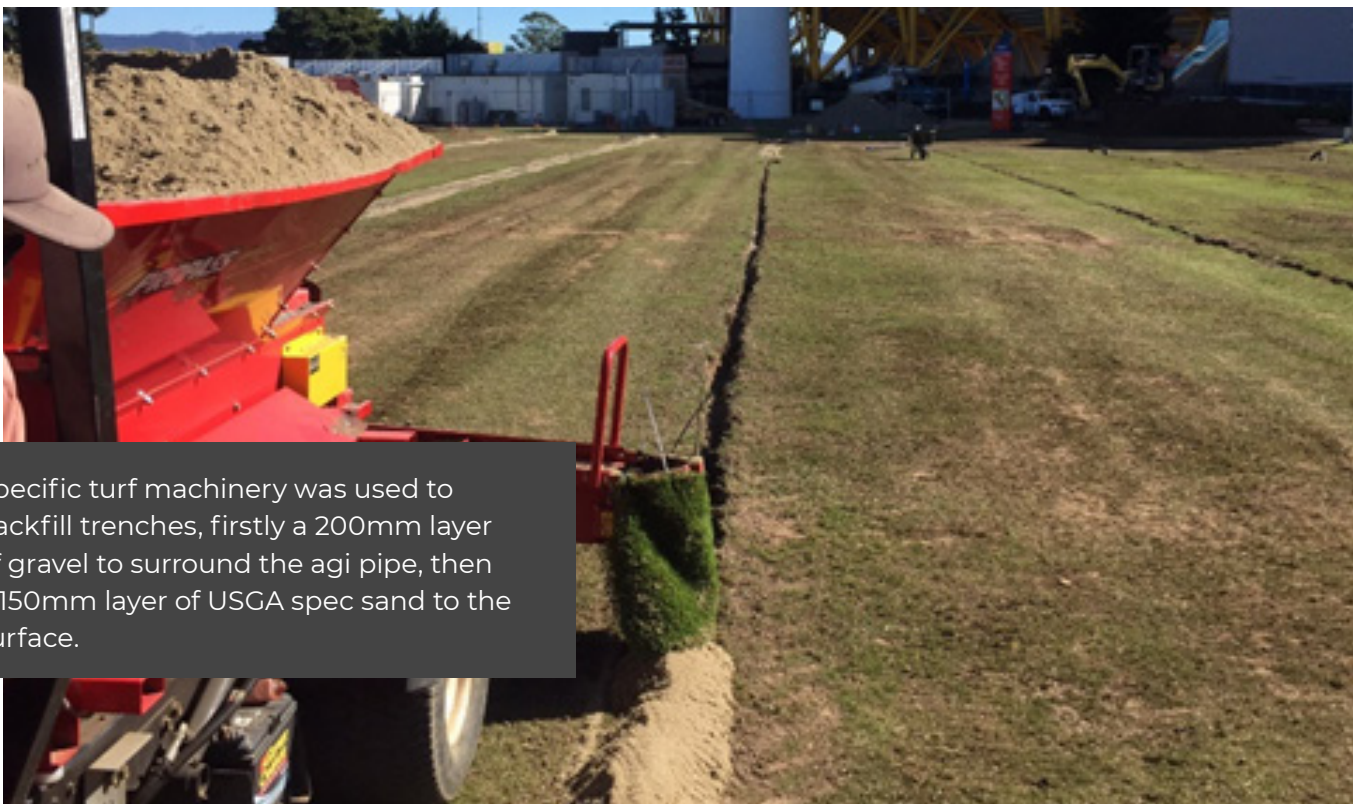
Specific turf machinery was used to backfill trenches, firstly a 200mm layer of gravel to surround the agi pipe, then a 150mm layer of USGA spec sand to the surface.

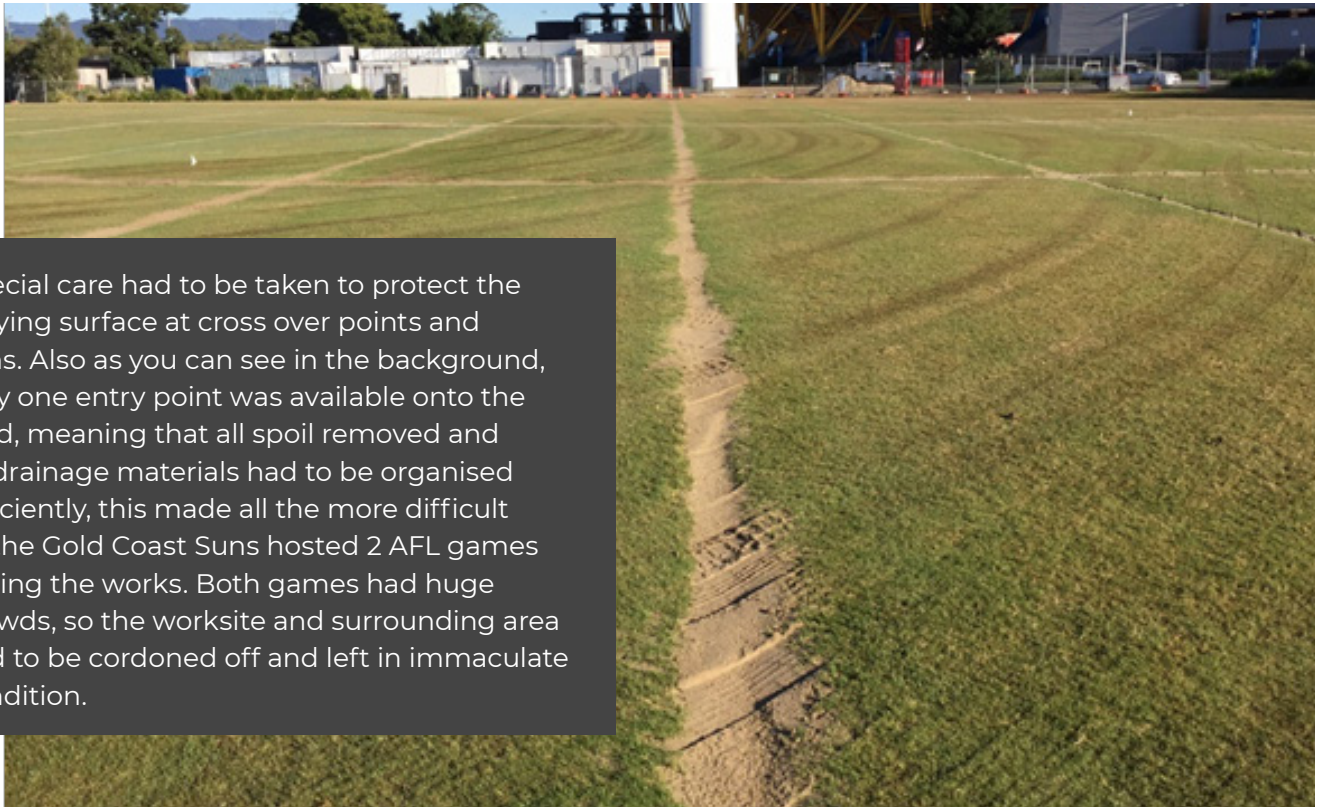
Special care had to be taken to protect the playing surface at cross over points and joins. Also as you can see in the background, only one entry point was available onto the field, meaning that all spoil removed and all drainage materials had to be organised efficiently, this made all the more difficult as the Gold Coast Suns hosted 2 AFL games during the works. Both games had huge crowds, so the worksite and surrounding area had to be cordoned off and left in immaculate condition.

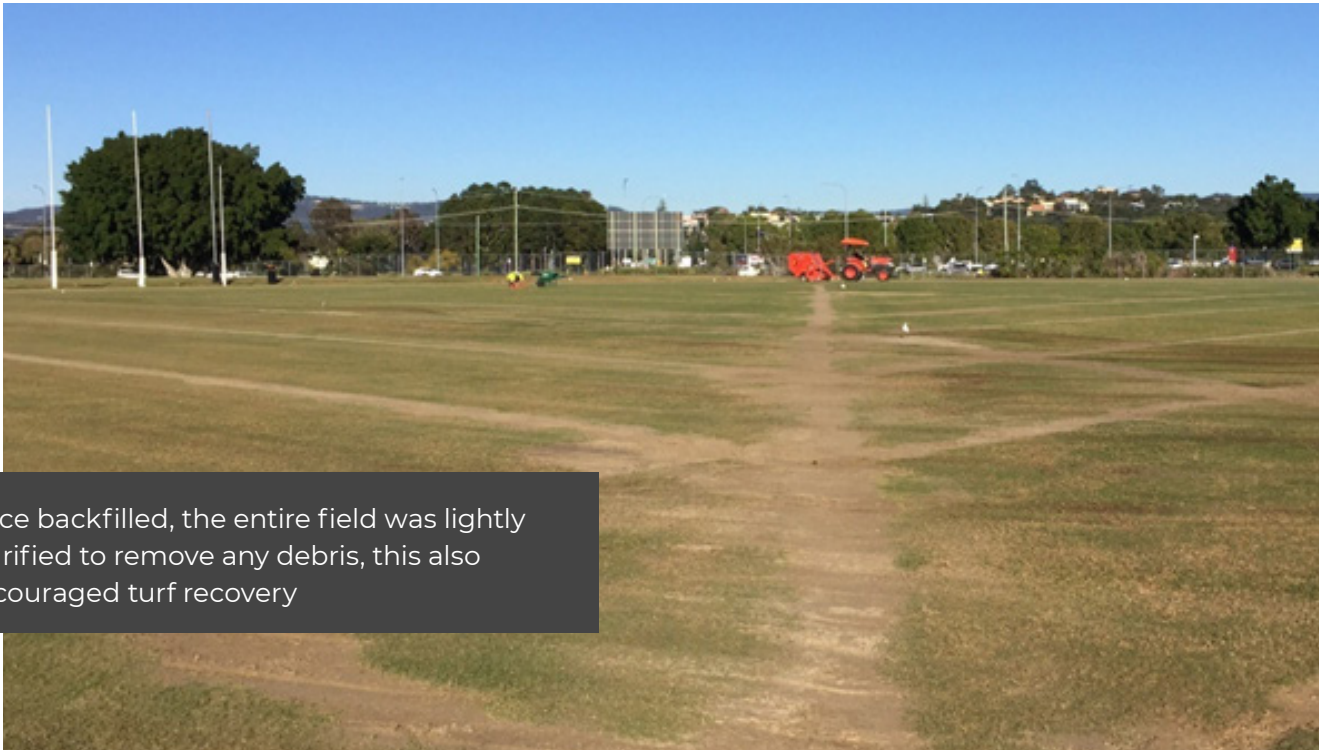
Once backfilled, the entire field was lightly scarified to remove any debris, this also encouraged turf recovery

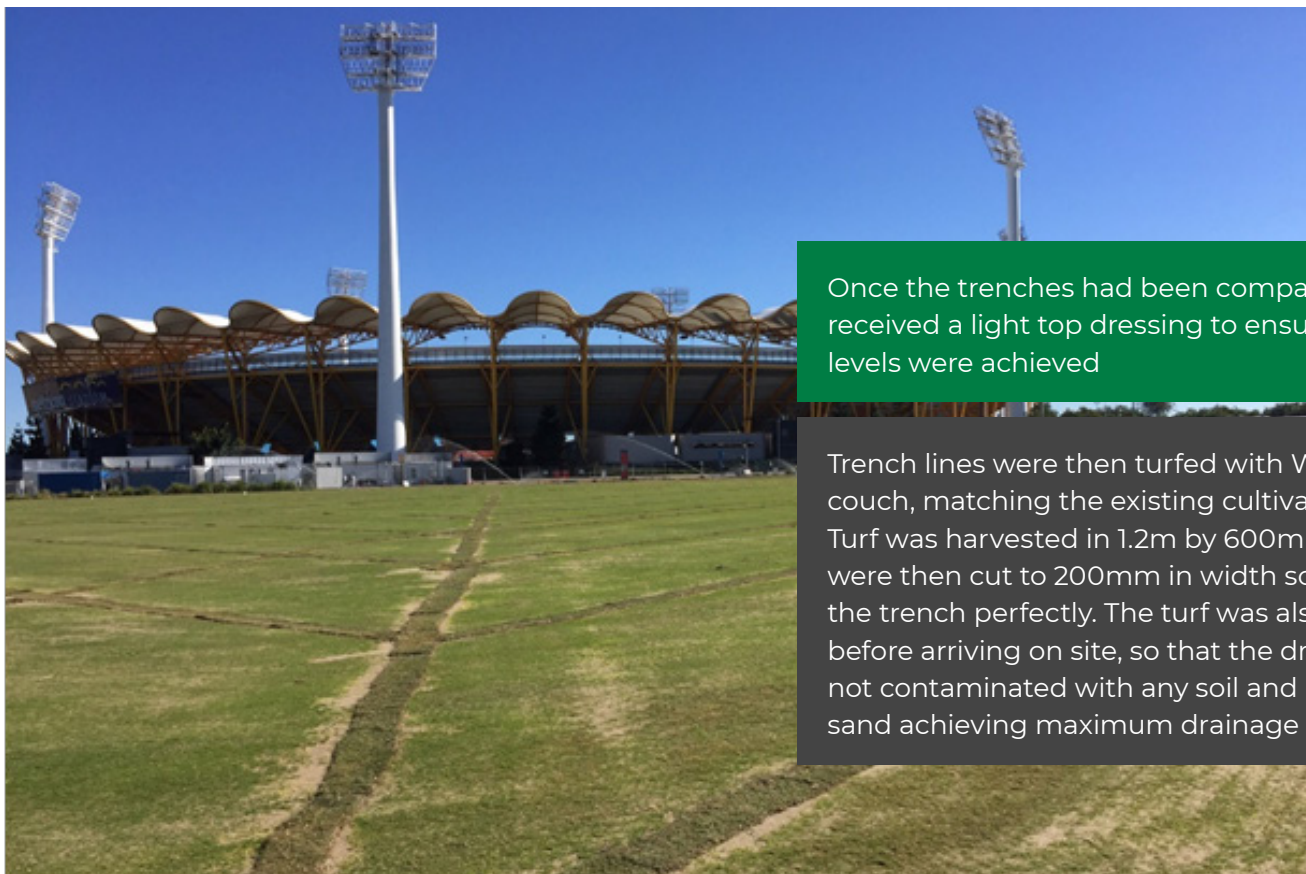
Once the trenches had been compacted, the field received a light top dressing to ensure the perfect levels were achieved

Trench lines were then turfed with Wintergreen couch, matching the existing cultivar on the field. Turf was harvested in 1.2m by 600mm slabs which were then cut to 200mm in width so as to cover the trench perfectly. The turf was also washed before arriving on site, so that the drain lines were not contaminated with any soil and remained pure sand achieving maximum drainage capacity.

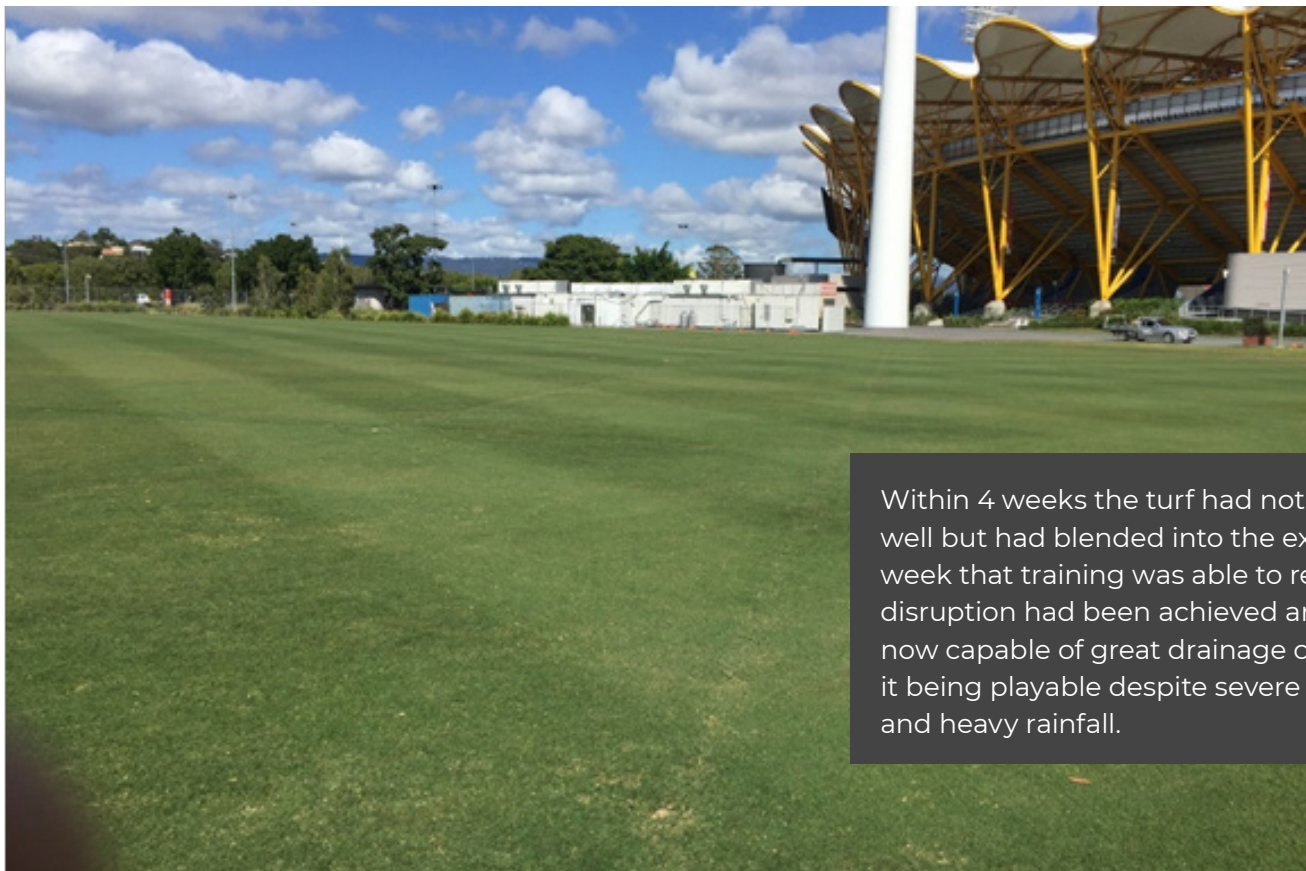
Within 4 weeks the turf had not only taken well but had blended into the existing field so well that training was able to resume. Minimal disruption had been achieved and a field was now capable of great drainage characteristics, it being playable despite severe thunderstorms and heavy rainfall.
