Sheldon college field build

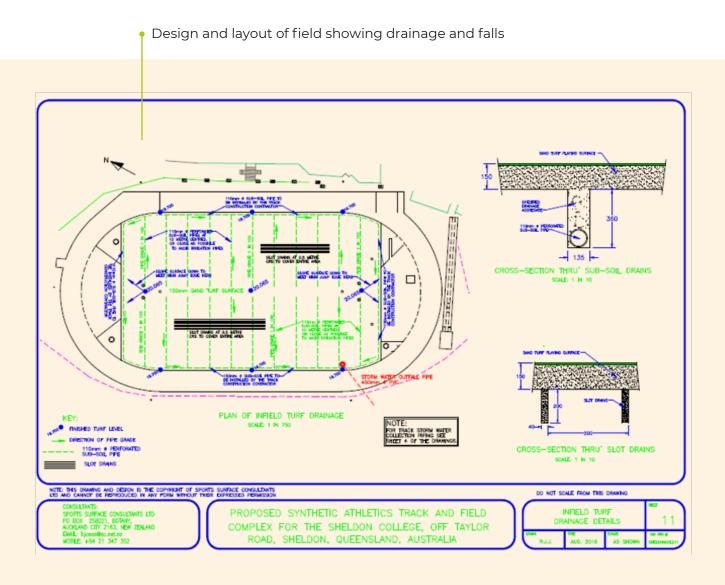
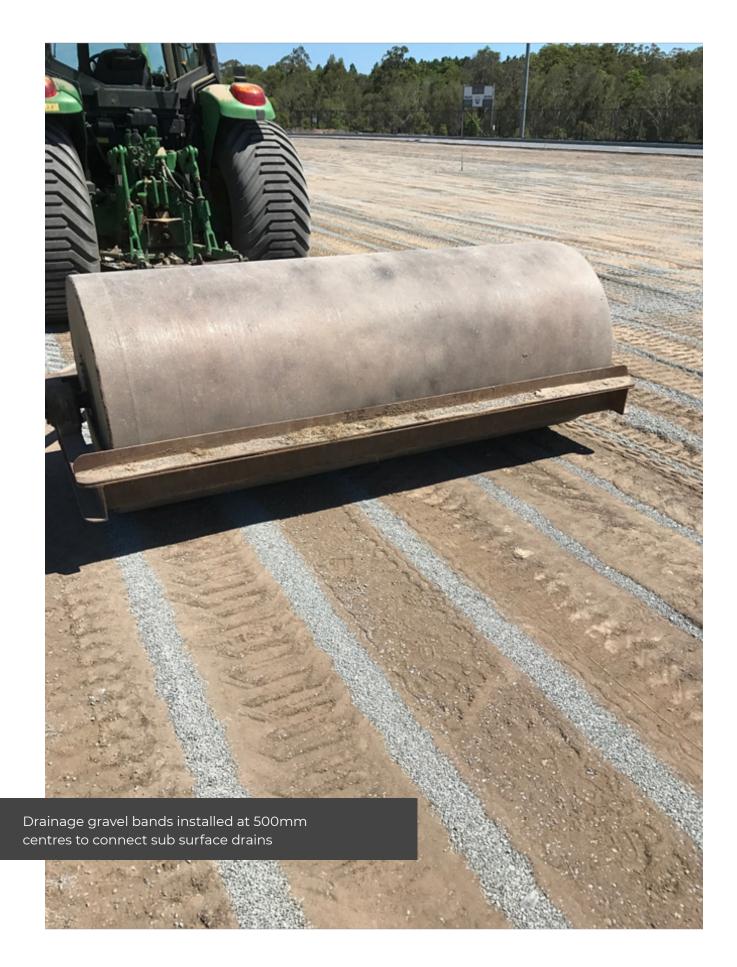
Hanceys turf worked successfully with Polytan at Runaway bay sports super centre two years ago so when consultant Bob Jones came to select two contractors to build an artificial athletics track and grass infield he had no hesitation in employing the same two companies again. Previously a grass running track and AFL oval, Sheldon college decided to build a rubber crumb running track surrounding a natural turf infield to be used for rugby union, league and soccer. The consultant's specifications were to remove 200mm of existing site soil, level this new subgrade, install a new irrigation system connected to the old main inlet and pump system. The drainage system specified for 100mm agi pipes in trenches at 300mm below finished subgrade heights east to west across the field and topped up to subgrade level with 5mm gravel all on a 1% fall to an outer 150mm ring main drain. Hanceys then installed gravel bands North to south along the field 500mm apart at a depth of 200mm to connect all the sub surface drains, using Hanceys Koro top drain gravel/sand banding machine. This machine can be set at various depths to a maximum of 250mm, creates 50mm wide slits, removes spoil and back fills with specified material and compacts the trench all in one pass, 3 trenches at a time.

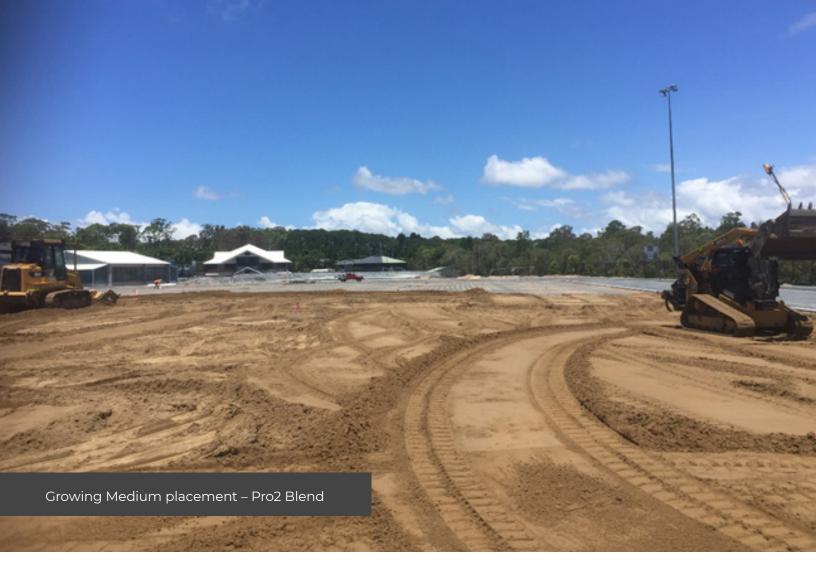
With this stage of works complete importing of the rootzone layer could begin. Truck and dogs brought the 3000tonnes of pro2 blend sand material from the Riversands quarry at Carbrook but they obviously couldn't drive on the subgrade and damage the drainage so dropped material on the edge of the field where a D6 Drott (set on the correct levels using a total station) created a pad and pushed the sand out from there. A possi track bobcat with laser levelling blade was then used to final trim the field before turfing.
