# Colleges Rugby Union

*Hancey's Turf was contracted to drainage and re-surfacing works for the Colleges Rugby Union Club and Griffith University at their campus ground on Benowa rd., at Ashmore. The club had contacted the Sports Turf Research Institute (STRI) to assess the condition of the playing field and recommend remedial works to improve the surface's performance.*

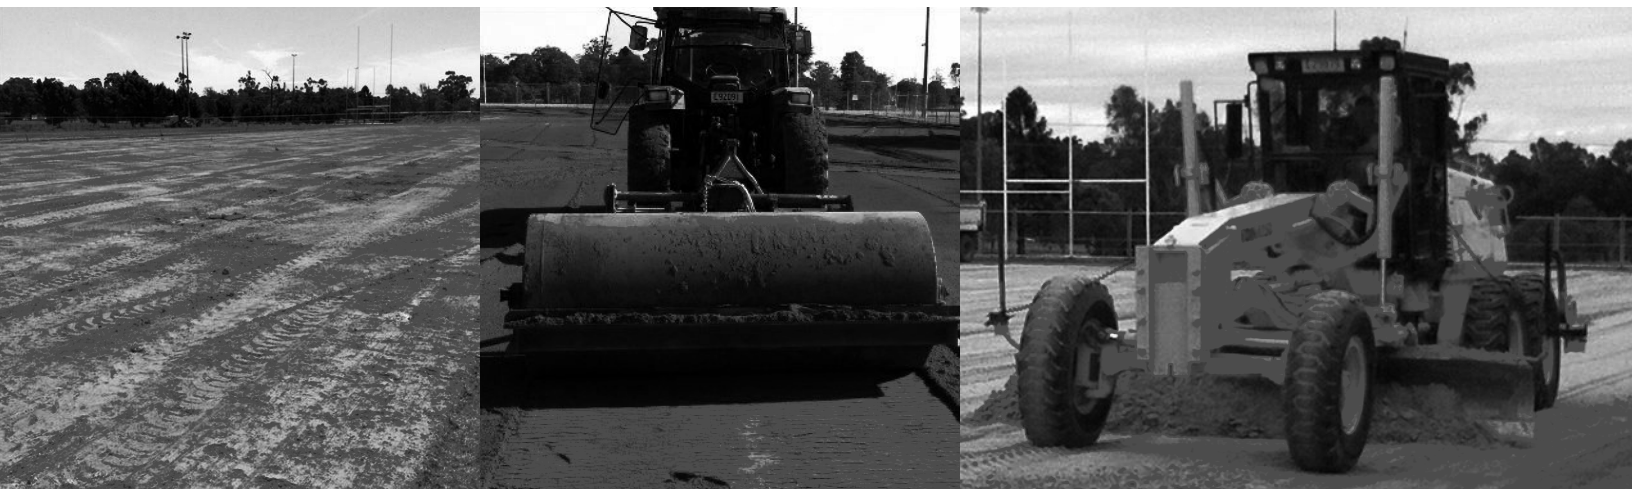
After de-compaction the field levels need to be re-shaped prior to the drainage installation. It was decided that the standard crown shape be given to the field, with the centre spot being the highest point on the pitch with falls of 1.4% (or 1 in 70) in all directions from there.
