# Narangba Sports complex

30,000 m<sup>2</sup>

Hancey's Turf was sub-contracted by Naric civil ltd, to build one full size soccer field and one junior soccer field for Morton Bay Regional council. The project also included 15,000 square meters of turf in the surrounding areas.

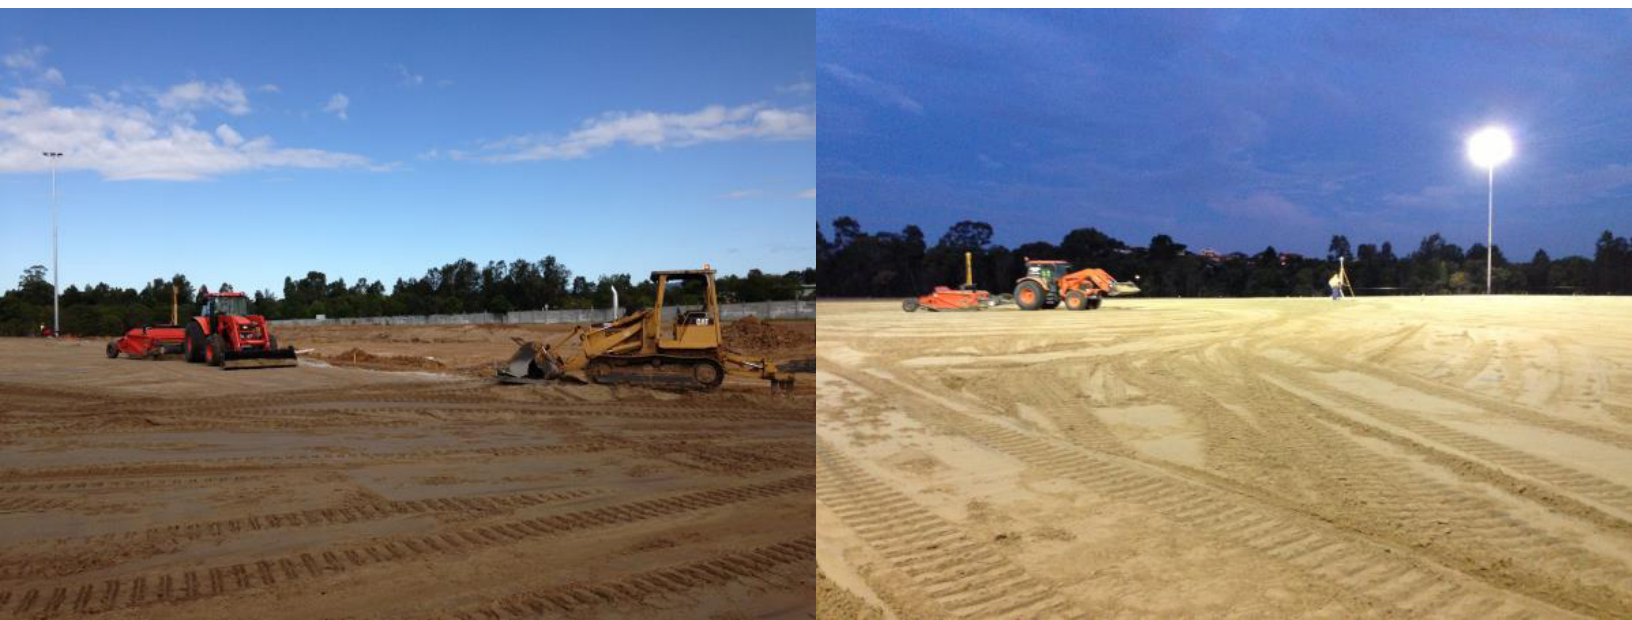
5 A 250mm thick layer of topsand growing medium was to be placed without unnecessary compaction onto the sub grade. This was achieved by forming a platform in one corner of the field and a small Drott and Dozer were employed to push the material out from there. While this was a slow procedure, this methodology was essential to ensure the imported material was not compacted, there was no contamination of materials and the sub grade remained de- compacted after the ripping and gypsum application as no machinery was allowed onto it. Some six thousand tonnes of material were imported and pushed out over the 12500 square meters of adult and junior fields. The 90% sand, 10% peat moss material was brought to and dropped on site by approximately 180 truck and dogs over a 5 day period, meaning all materials could be pushed out within 6 days. Hancey's Turf then employed a tractor and laser bucket to grade the material to within +/- 5mm, this taking two days to be as accurate as possible as all levels now had to come within a +/- 5mm tolerance on a 5m x5m grid survey.

6 Project Irrigation, the irrigation contractors, now took control of the fields for 3 days to install the pop up irrigation system and handed it back to Hancey's once all checks on the system had been passed. Tolerances were re checked at this stage.

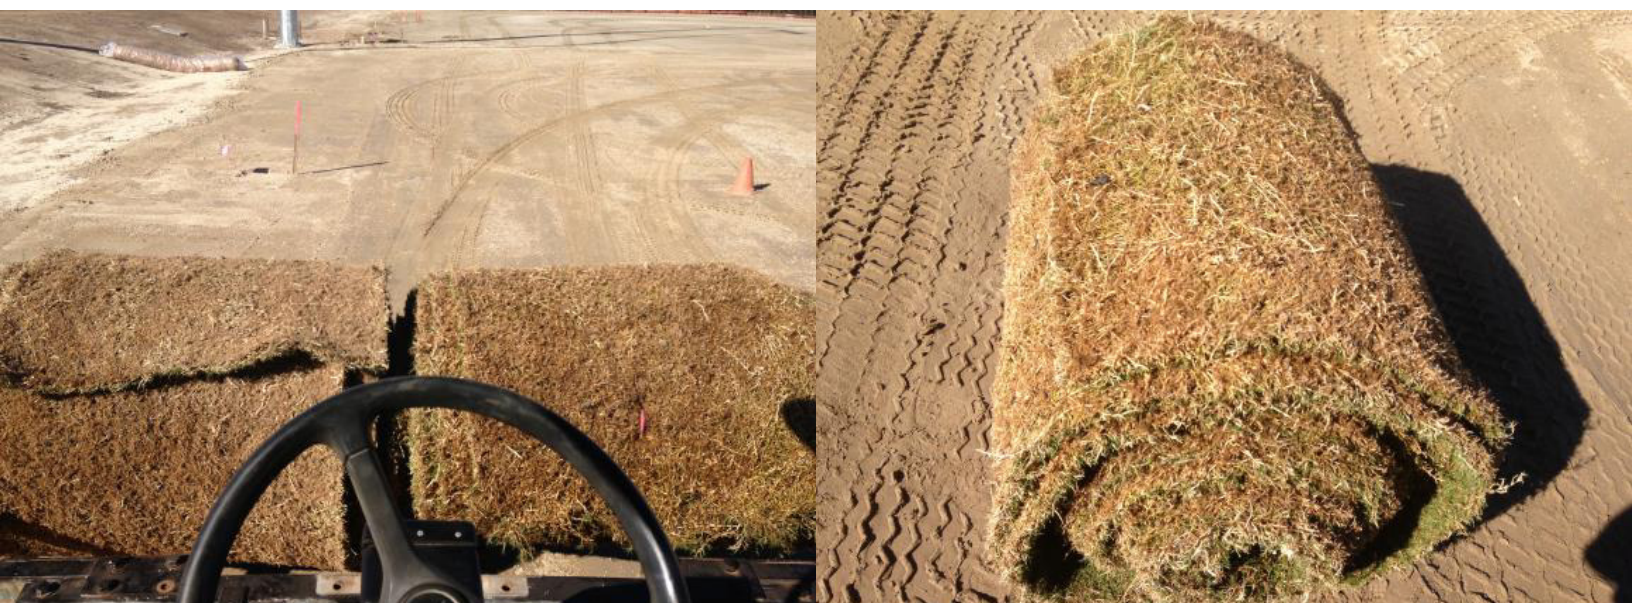
After tolerances had been passed by the council survey, a series of compaction tests ("clegg hammer testing") were completed to assess infiltration rates and compaction levels had not been affected during placement and laser grading. All tests revealed minimum compaction and adequate water movement through the profile so we were able to begin the turfing component of works. Specifications required washed rolls 'Wintergreen' couch grass, turf measuring 1.2m by 20m long. Hancey's Turf are able to set specialist machinery to meet any specifications when harvesting turf from they're Woodford farm base. Here the turf is also washed using our own high pressure turf washer and in one pass all soil is cleanly removed, maintaining quality of turf and ensuring there can be no contamination of materials once the turf is layed. This procedure is highly recommended for all high profile sports ground construction especially sand based fields and cricket wicket blocks. 2500 square meters of turf was harvested, washed, delivered to site and layed per day meaning the field was completed within a week by Hancey's laying team to the high standards required. The field was rolled in several directions to bed the turf in, essential when working with washed turf, fertilised and watered heavily. Mark Patterson set the watering program to irrigate 5 times daily at this early stage. When working with washed turf it is paramount that the top surface (leaf of the plant) is kept moist as the turf has no soil to gain moisture from until roots establish a week after turfing. Constant assessment is required for the first 10 days until root growth occurs, then watering is slowed gradually before eventually set to just twice weekly so that root growth and root depth is encouraged to increase significantly.
